"Truss Plate Performance in Fire: One Person's Observations" by John E. Meeks, P.E.

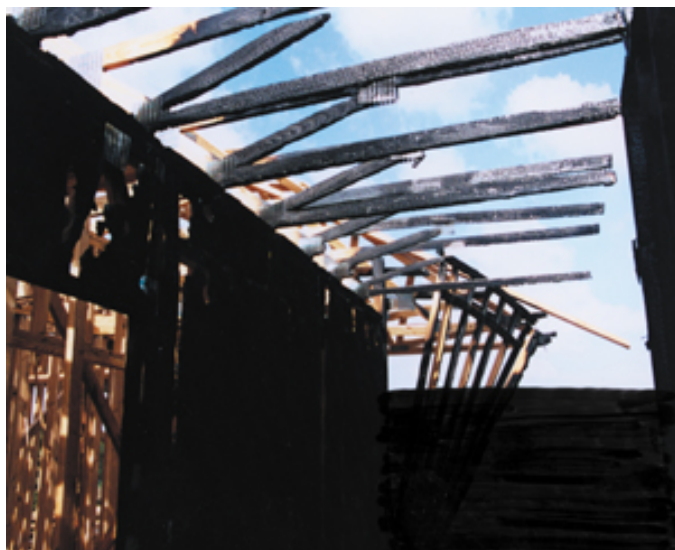
PHOTO 1

But what happens if a fire gets started while a building is under construction and before the fire protection has been installed? How does light framing perform under these conditions? Of more interest to the wood truss industry, how do connector plates perform when directly exposed to fire? Photo 1 shows 2x4 wood trusses exposed to severe fire. The 2x4 lumber is greatly reduced in cross section but the connector plates are still holding the charred members together. These truss remains are not capable of supporting much load, if any, but there was enough gripping strength in the wood beneath the connector plates to maintain the shape of the trusses. The truss members beyond the exterior wall show little damage.

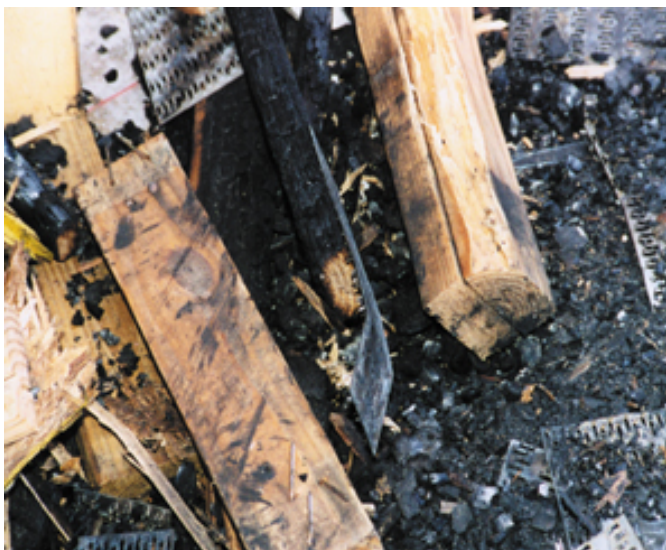
PHOTO 2

After every fire there is an abundance of debris. It is usually difficult to identify the burned sections and to find meaningful evidence. In photo 2 there are numerous connector plates that appear to have been burned completely away from the trusses. The plates themselves appear to have minor damage, but of course are not re-useable. There is also a close look at a spliced 2x4 with a plate missing from one side. But note that the remaining plate is firmly attached to the 2x4 and, most importantly, the lumber appears to have been somewhat protected by the connector. The protected wood is visible at the splice point.

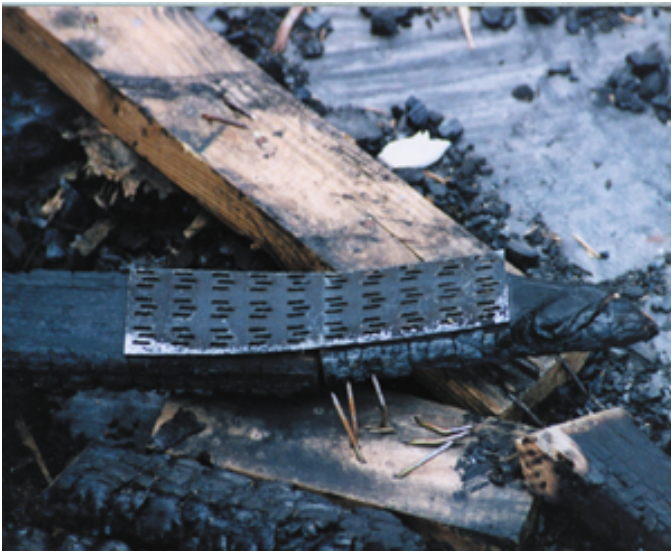
PHOTO 3
CLICK ON IMAGE FOR LARGER VIEW

More debris on the floor slab in photo 3 shows the bottom chord splice of a 4x2 flat chord floor truss. A heavy gauge splice plate (probably 16 gauge) has protected the lumber where it is in contact, but the lumber burned all the way through just a few inches from the splice. A few inches from the splice plate there is a double cut 4x2 flat chord floor truss web member. Teeth marks from a missing connector can be seen at a well-protected joint. The web is severely charred just beyond the protection of the connector.

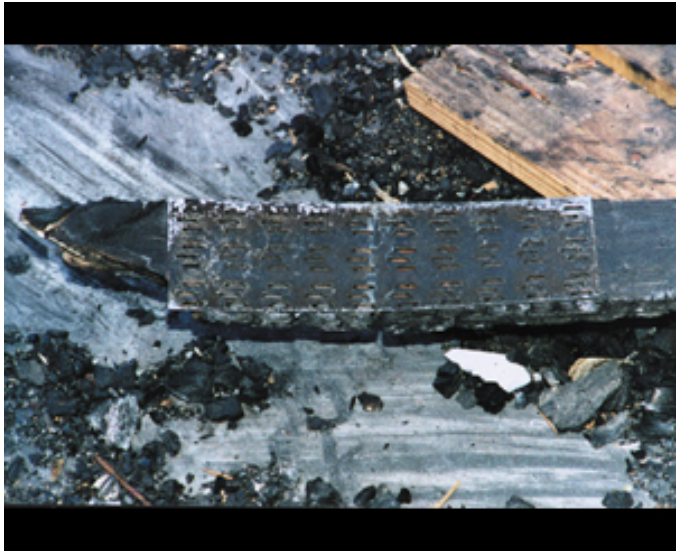
PHOTO 4
CLICK ON IMAGE FOR LARGER VIEW

As if to prove photo 3 was not a mistake, a similar bottom chord splice in a 4x2 floor truss was found a short distance away (photo 4). The heavy connector plate remains on one side only, the other side having had a greater exposure to the fire. A close look verifies that the wood seems intact directly beneath the connector plate, though charred all the way through just beyond the protection of the plate.

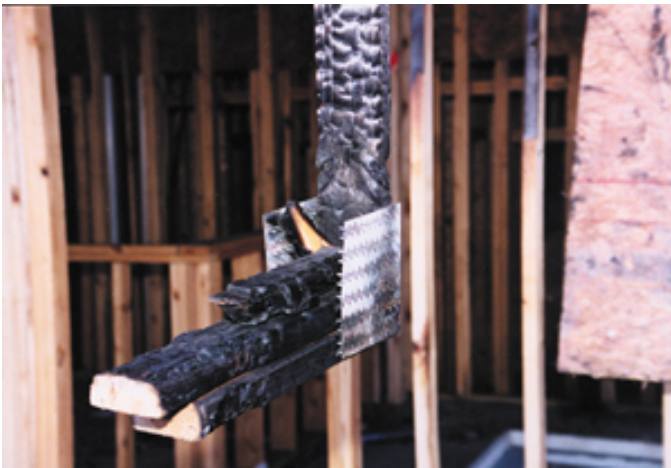
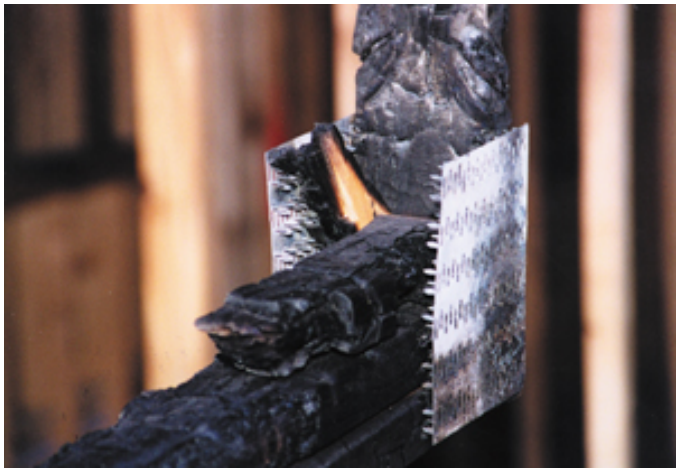
Photos 5 and 6 show the bearing end of a 4x2 flat chord door or window header remaining after being subjected to severe fire damage. The truss appears to have been designed to have a double bottom chord and compression first diagonals. The truss has severe fire damage. The end vertical of the truss has lost a great deal of lumber cross section. The connector plate appears to have protected the bearing joint and the first diagonal web shows a small section of bright lumber where it was broken away in falling to the floor. The end connector appears to have backed out of the wood, but in all likelihood the wood shrank away from the plate as it charred. The plate is still holding the charred wood parts together.

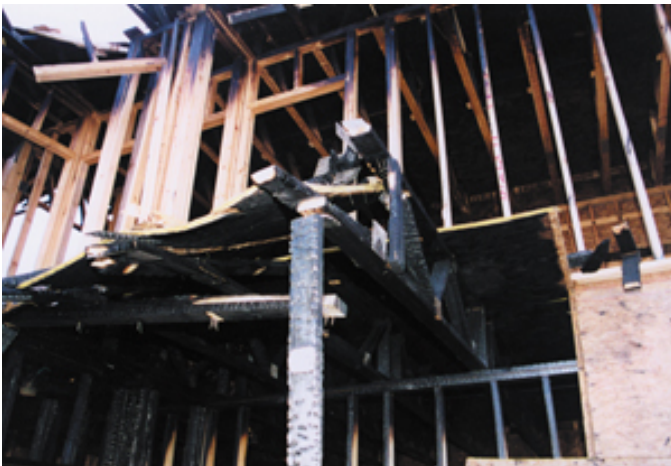
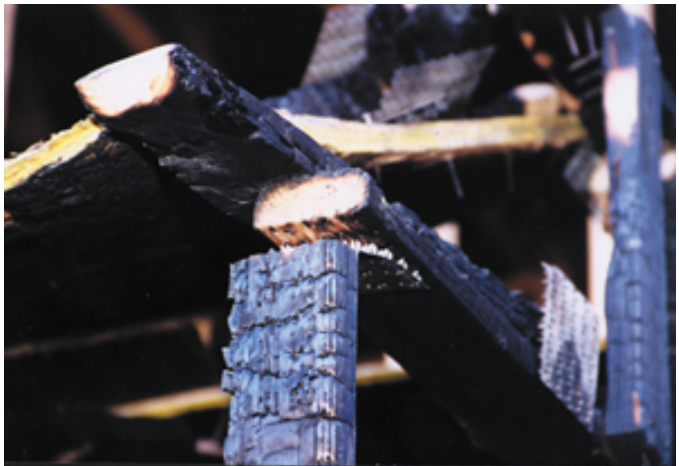
The flat chord, 4x2 floor trusses shown in photos 7 and 8, are supported on load bearing wood stud partitions and were subjected to intense fire, which burned through the plywood sub-floor sheathing. Scabbed vertical 2x4 members and strong back stiffeners were installed between adjacent trusses. The bottom chord splice was burned through from the top but the bottom splice plate was still holding. It is bent down by the failure of the bearing wall at the other end. The bottom chord lumber appears to have been protected to some extent by the bottom plate of the spliced joint. Also, note the double cut 4x2 web member nearby.
