Reading the PE Palm

Snow Damage Analyzed, Repaired

by Joe Heinsman, P.E., Davidson Lumber Company

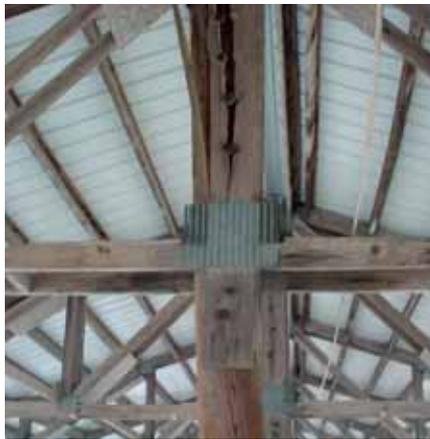
Figure 2. The trusses are a double Pratt design with 2x6 top chords and 2x4 bottom chords constructed of Southern Pine. The chords are all #1 grade and the truss plates 20 gauge. The distance from the concrete slab to the bottom of the trusses measures 15.5'. The 2x8 kingposts extend 14" through and below the bottom chord to allow for more bolts. Each pair of trusses is bolted to their pole with eight 3/4" diameter bolts more or less evenly spaced down the kingpost.

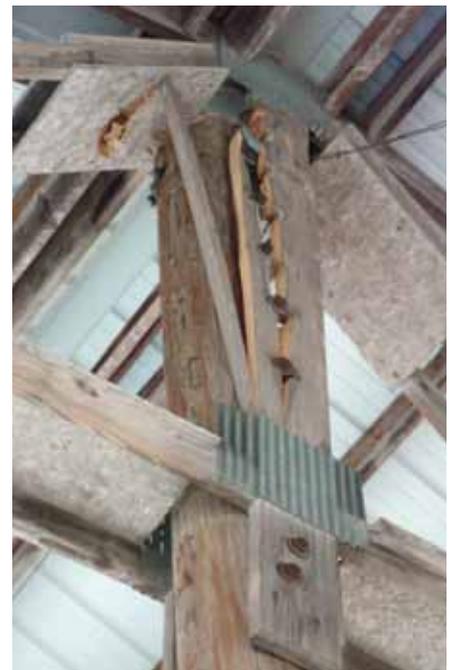
Figure 4. While five of the sheds were undamaged in the storm, the sixth received extensive damage. Major damage to the trusses was at the fifth, sixth and seventh poles from the east end of the shed. The seventh pole was split along the bolt holes (see also Figure 3). The sole witness to see the roof with the snow on it said the north side of the roof was clean while the south side had a drift that was 4.5' to 5' high at the eave. Where the eave was lowest he could jump up and touch it. He said the undamaged poles were bowed in the plane of the trusses toward the eave with the snow drift. There was about 18" of horizontal displacement at the top. The trusses on each side of the fifth and sixth poles and one side of the seventh pole had the kingposts split. The kingposts split at the bolt holes at the top but the split did not necessarily follow the bolt holes down.

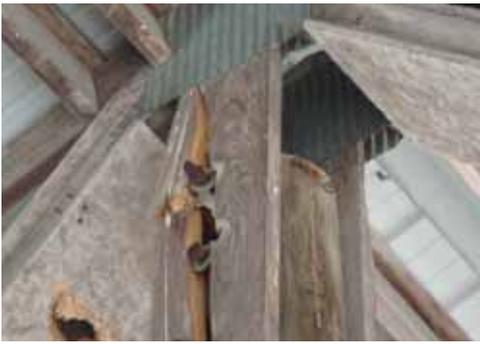
Figure 5.

The loaded part of the kingposts was broken off at or near the bottom of the peak truss plate (Figure 5). On some trusses, the kingpost was split below the bottom of the bottom chord where two of the eight bolts were located (Figure 6). In no case did the splits or damage to the wood extend past the first row of teeth into the plate area. All wood in the plate areas was intact and undamaged (Figure 7). The one damaged round pole was split at the bolt holes at the top and followed the bolt holes most of the way down the truss depth where it began tapering to one side of the post. The split ended about 4' below the bottom of the truss where it was getting close to one edge of the pole.
