## Parting Shots

### Parting Shots Contest Results

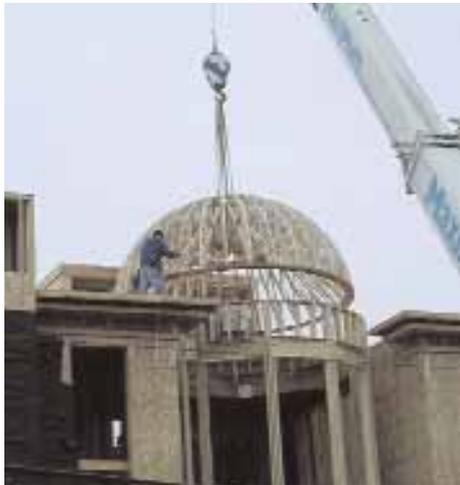
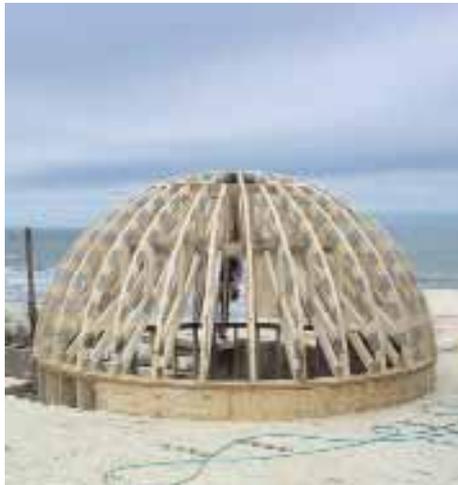
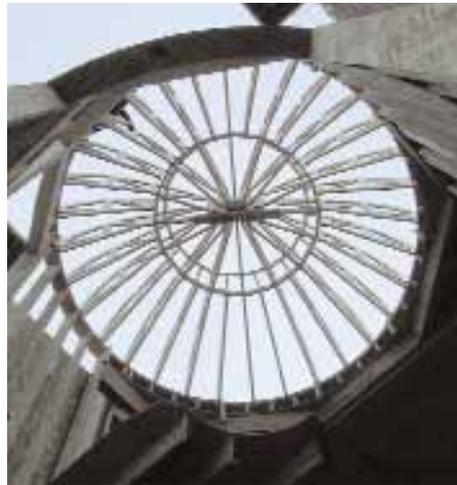
This trussed dome by Sam Yoder & Son, Inc. of Greenwood, DE was recently installed in a single family beachfront home in Rehoboth Beach, DE. Regular customer Bunting Construction encouraged technician Lamar Yoder to "think round" when coming up with a suitable design.

"It took me quite a while to get the proper radius and the exact look that the customer wanted," Yoder commented, adding that there are 24 segments in the top chord. "The installation couldn't have gone smoother," he noted. **SBC**

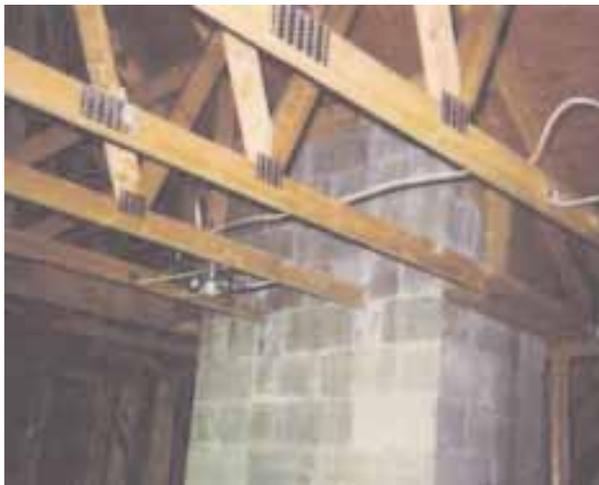
"My training and experience tells me that the bottom chords extend into and through the chimney. This is quite obvious because of the cuts made in the course of masonry block directly above the top of the bottom chord and in the course of masonry block directly below the bottom of the bottom chord so that the block could be installed over and around the bottom chord. You can see the mortar surrounding the bottom chord member at the cut. If the bottom chords ended at the face of the masonry block there would not be the need for a mortar joint where the chords intersect the block. There are probably terra-cotta flues that extend upward between the truss bottom chords and have some amount of block between the wood chord and the flue lining."

"In this picture, the chords have not been cut yet. The chimney was built around the truss. That is, both the top chord and bottom chord go in one side of the chimney and exit the other side. I had to provide a repair drawing showing how to stub the truss back to the chimney where bearing was provided by the contractor. I congratulate Mr. Tepper for his power of observation!"

Remember this photo from the April issue? We received a number of responses from readers with their thoughts on the state of the trusses in this photograph. **Harold M. Tepper, PE**, of Tepper Associates submitted our winning answer:
