Reading the PE Palm

Snow Damage Analyzed, Repaired

by Joe Heinsman, P.E., Davidson Lumber Company

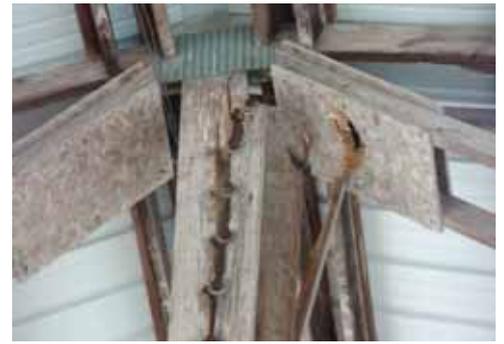
Figure 7.

The loaded part of the kingposts was broken off at or near the bottom of the peak truss plate (Figure 5). On some trusses, the kingpost was split below the bottom of the bottom chord where two of the eight bolts were located (Figure 6). In no case did the splits or damage to the wood extend past the first row of teeth into the plate area. All wood in the plate areas was intact and undamaged (Figure 7). The one damaged round pole was split at the bolt holes at the top and followed the bolt holes most of the way down the truss depth where it began tapering to one side of the post. The split ended about 4' below the bottom of the truss where it was getting close to one edge of the pole.
